## BELFOR Environmental's Asbestos And HazMat Teams Work Together And Remediate Contamination On A Former Oil Site

# CASE STUDY

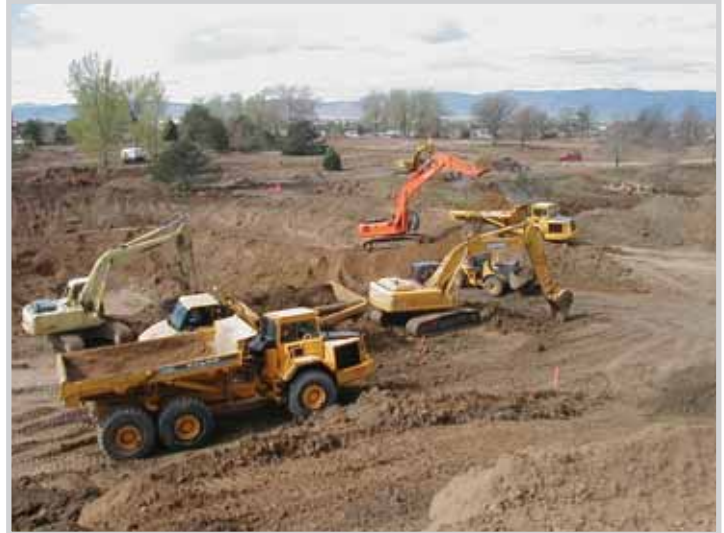
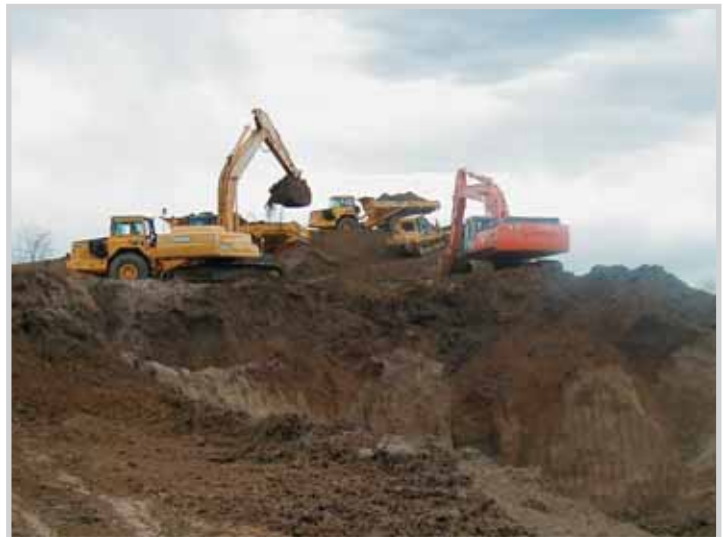
Based on their understanding of asbestos challenges, the Colorado regulatory agencies and EPA allowed them to perform open-air abatement, speeding up the process. Asbestos teams set up wind fences to isolate work areas and misting along contamination lines. They followed up saturating the ground with fire hoses a foot deep before removal of substances. Finally, end-dumps were used to wrap, seal and dispose of 2,500 cubic yards of asbestos contaminated soil.

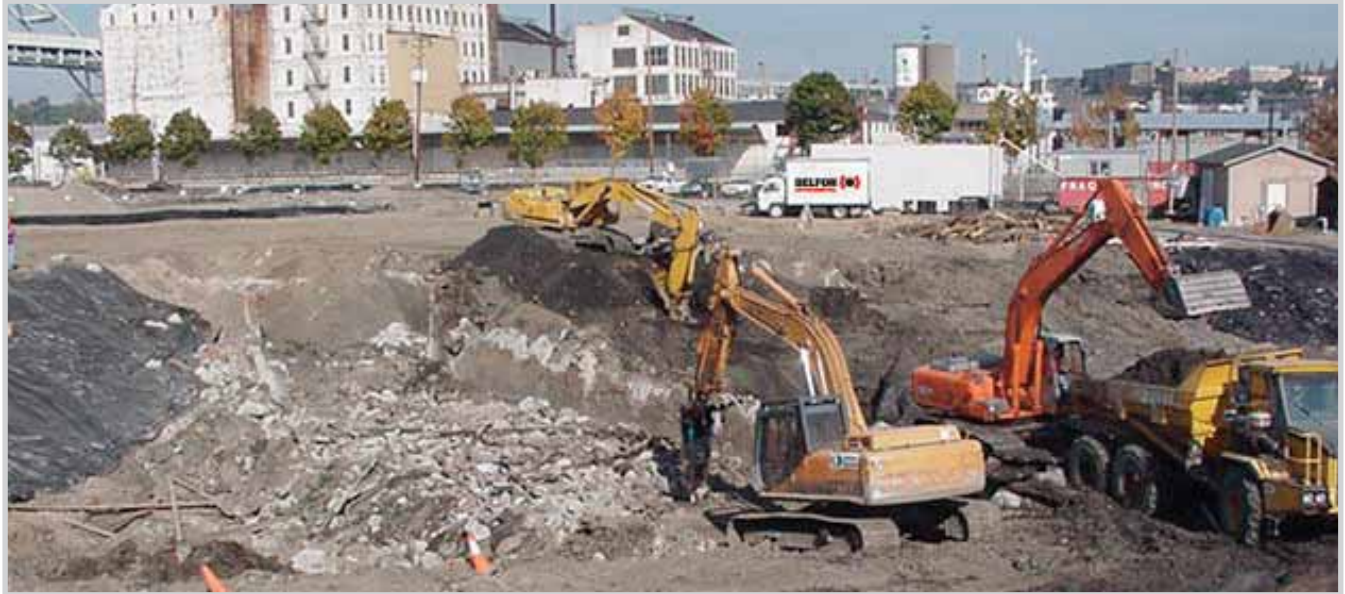
Concurrently, HazMat teams excavated and staged clean overburden from the hydrocarbon-contaminated areas. They removed the petroleum and acetone contaminated soil at depth. BELFOR Environmental returned the clean soil to the excavation site following removal of the contaminated soils and graded the entire site. The HazMat team disposed of 20,800 cubic yards of soil and 90,000 cubic yards of overburden was removed and replaced - all within the original 30-day schedule.
